Chemical Accident Prevention & Preparedness

Learning from incidents involving liquefied petroleum gas (LPG)

This 14th issue of the Lessons Learned Bulletin (LLB) accompanies the publication of the JRC's Good Practice Report on Risk Management and Enforcement on Liquefied Petroleum Gas (LPG) and Liquefied Natural Gas (LNG) Sites. The Good Practice Report provides an extensive description of the properties of LPG and typical risks associated with LPG production, storage and handling. This issue of LLB focuses on incidents involving LPG mostly on fixed sites however many incidents with LPG on transport have been considered as well. In total 88 incidents have been studied for the purpose of this LLB.

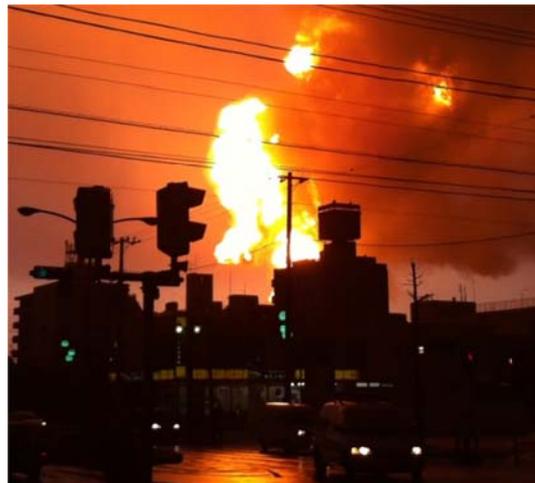
Important findings There were 17 tanks in the LPG storage farm area of the industrial complex. During maintenance the tanks are filled with water to check that the equipment still performs to design pressure (hydrostatic testing), a practice that normally takes place over the course of 2-3 days. On March 11, Tank no. 364 was holding water for 12 days. Also, before the earthquake, there was a confirmed leakage of air from the hose to which air was supplied to activate the emergency shut-off valve. As a temporary measure this valve was switched to open until the hose could be repaired. This meant that the emergency shut-off function had been disabled. In manually switching of the emergency valve to the “open” position, the operator was in violation of existing law. Not only could the valve not be closed through activating the pneumatic system, it could not close through the melting of the pneumatic hose in the event of a fire which is a safety function of pneumatically operated valves. Unfortunately, this emergency shut-off valve stayed open at the time of the earthquake too. After the first earthquake, the bracing of the LPG tank no. 364 suffered some damage since the tanks were designed for holding LPG and not for the temporary confinement of water, whose weight is 1.8 times heavier than LPG.

The damage was not identified during the visual inspection after the main shock at 14:46 hrs. It is difficult to visually inspect a tank of 20 m diameter and 2000 kl capacity in a short period of time. At 15:15 the aftershock occurred. The emergency valve was still not closed as it was wrongly assumed that the integrity of the tank was not compromised. At 15:20 the legs failed and the entire tank collapsed. The collapse damaged the neighboring pipelines and triggered a release of LPG.

Figure 3 Cosmo oil refinery explosion 11 March 2011 (Wikipedia) (This file is licensed under the [Creative Commons Attribution-Share Alike 3.0 Unported license](https://creativecommons.org/licenses/by-sa/3.0/).)

The tank was not designed to resist a strong earthquake while carrying water, so it failed and triggered a catastrophic sequence of events. LPG tanks can be vulnerable to the impacts of natural hazards, including earthquakes, strong winds, hurricanes and floods. Maintenance functions may increase the

vulnerability of LPG systems because they are abnormal operations, and protections can sometimes be disabled temporarily for maintenance purposes. For this reason, it should be routine to include natural hazard impacts in job risk analysis for maintenance tasks to ensure that control measures are in place to minimize the chances that a natural hazard will damage the equipment.
