# Report on renovated riparian vegetation on river Jadro and Vrljika

| <b>Project name</b> | Improve River LIFE – Improving the conservation status of target Natura 2000 species and habitat types through improved river connectivity |
| <b>Title</b> | Report on renovated riparian vegetation on river Jadro and Vrljika |
| <b>Label and name of the delivery</b> | Deliverable D2.5 – Report on restored riparian vegetation on river Jadro and Vrljika – First draft |

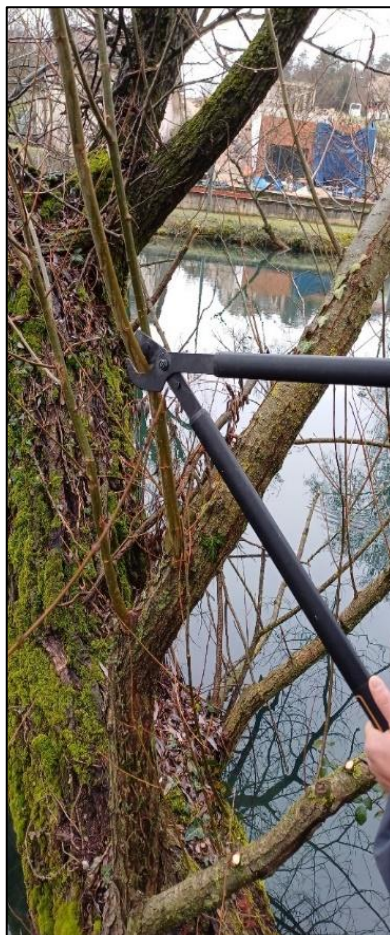
Figure 2. Collecting cuttings

To collect the cuttings, two-handed scissors were used for thicker cuttings, and hand-held viticulture scissors for thinner cuttings, pictures 2 and 3 below.

The cuttings were cut with two-handed or hand shears, depending on the thickness, approximately 50 cm long, and then planted in moist soil. Both thicker and thinner cuttings were used to avoid unnecessary waste. After the cutting was taken, the thicker end was cut sharply at a 45° angle so that it could be pushed into the soil more easily; if it was a thicker cutting, then the upper end was cut straight, so that it could be pushed in by hitting it with a hammer if the soil was harder.

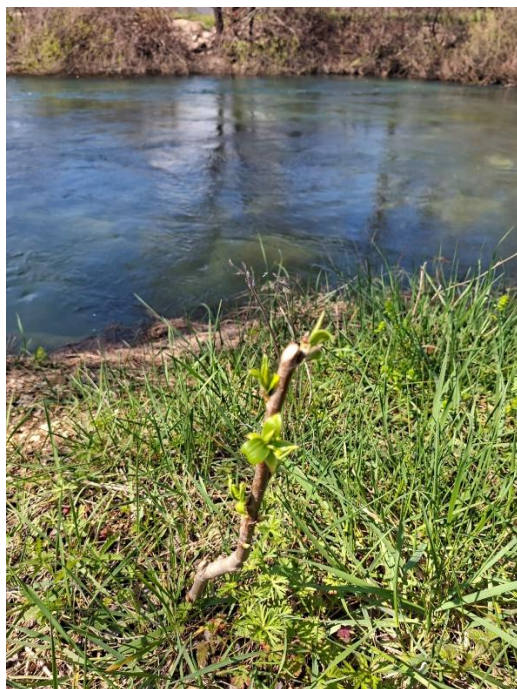
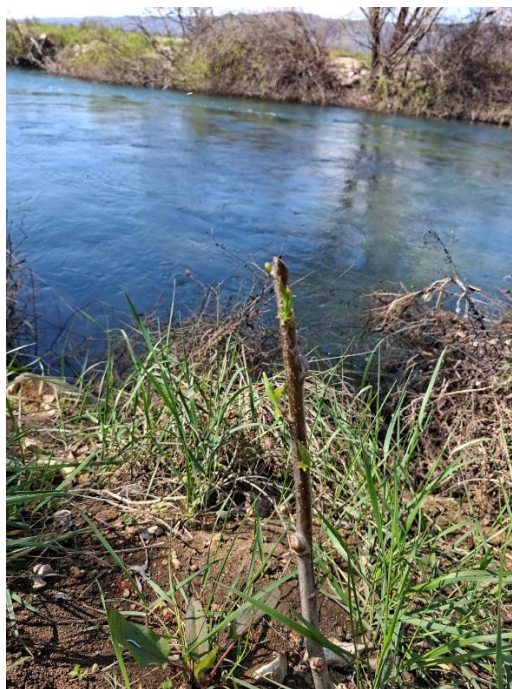
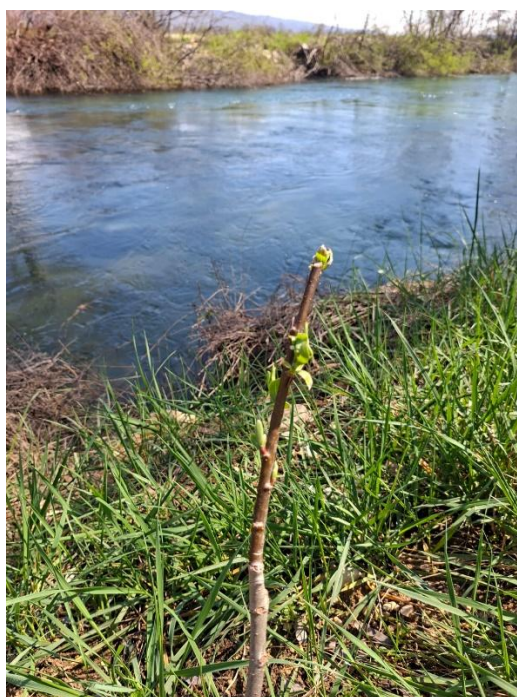
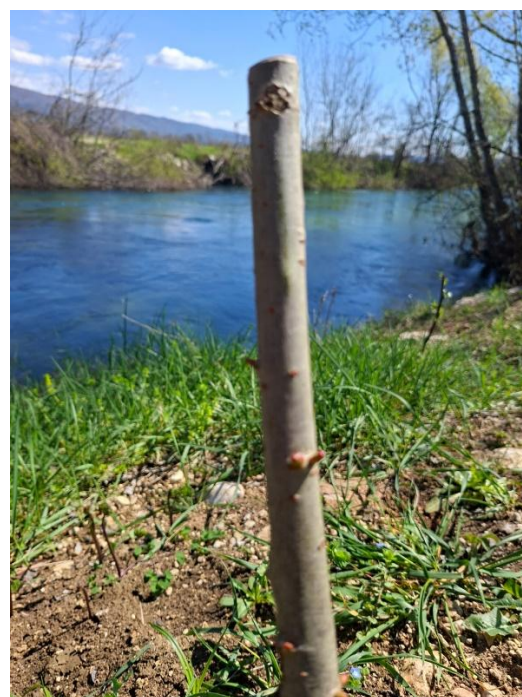
**Figure 4.** Examples of rooted willow cuttings

Visual inspection revealed a high success rate of cutting survival. Of the total number of cuttings, 50, or 83%, have sprouted or budded. Monitoring continues to monitor the health of young plants and to prevent damage due to anthropogenic activities. This high success rate of cuttings is an indication that an appropriate propagation method and species selection have been selected (Figure 4).

Employees of the project partner, Public institution Sea and Karst, regularly inspect the plants every week. So far, there has been no need for intervention in the form of mowing weedy vegetation or protection from herbivores and anthropogenic factor.
