MACROPHYTE CONTROL PLAN IN JADRO AND VRLJIKA RIVERS

Project name	Improve River LIFE - Improving the conservation status of target Natura 2000 species and habitat types through improved river connectivity
Project number	LIFE22-NAT-HR-Improve River LIFE/101114250
Title	Macrophyte control plan in Jadro and Vrljika rivers
Authors	State Institute for Environmental and Nature Protection, Ministry of Environmental Protection and Green Transition
Document date	January, 2026
Task number and name	T.2.4 Control of macrophyte vegetation
Deliverable number and name	D2.3 – Macrophyte control plan
Recommended citation	MEPGT (2026): Macrophyte control plan in Jadro and Vrljika rivers, Ministry of Environmental Protection and Green Transition

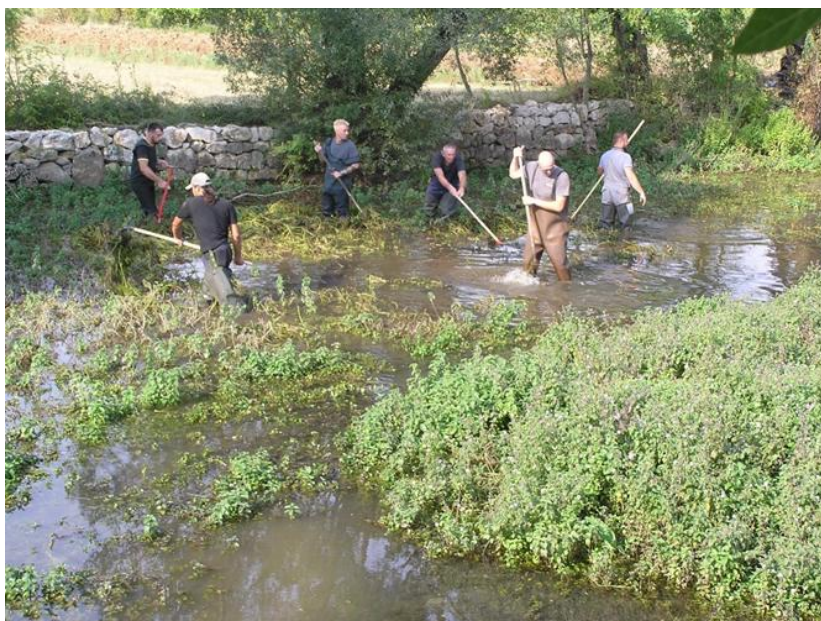
Figure 2. Macrophyte removal in the Special Ichthyological Reserve Vrljika Spring, 3–4 September 2024 (Public Institution More i Krš, 2025a).

Aquatic vegetation was removed exclusively manually by cutting, according to the permission issued by the Ministry of Environment and Green Transition, without using mechanical or chemical vegetation control methods. Manual cutting, although the most ecologically appropriate, proved to be extremely demanding and time-consuming due to the density and resilience of vegetation in the area. This method requires a large workforce, the removal process is very slow, the available period for removal is short, and it is only feasible in the shallower parts of the river (Public Institution More i krš, 2025a).

Despite intensive efforts and the engagement of a significant number of staff from the Public Institution and Croatian Waters (Imotski), the set objectives were not fully achieved (Public Institution More i krš, 2025a). Due to specific field conditions, inaccessibility of certain parts of the watercourse, and dense, firmly rooted vegetation, manual removal proved ineffective. This prevented achieving the necessary level of riverbed cleaning, and consequently, did not contribute to an increase in water flow or improvement of the river's ecological balance.

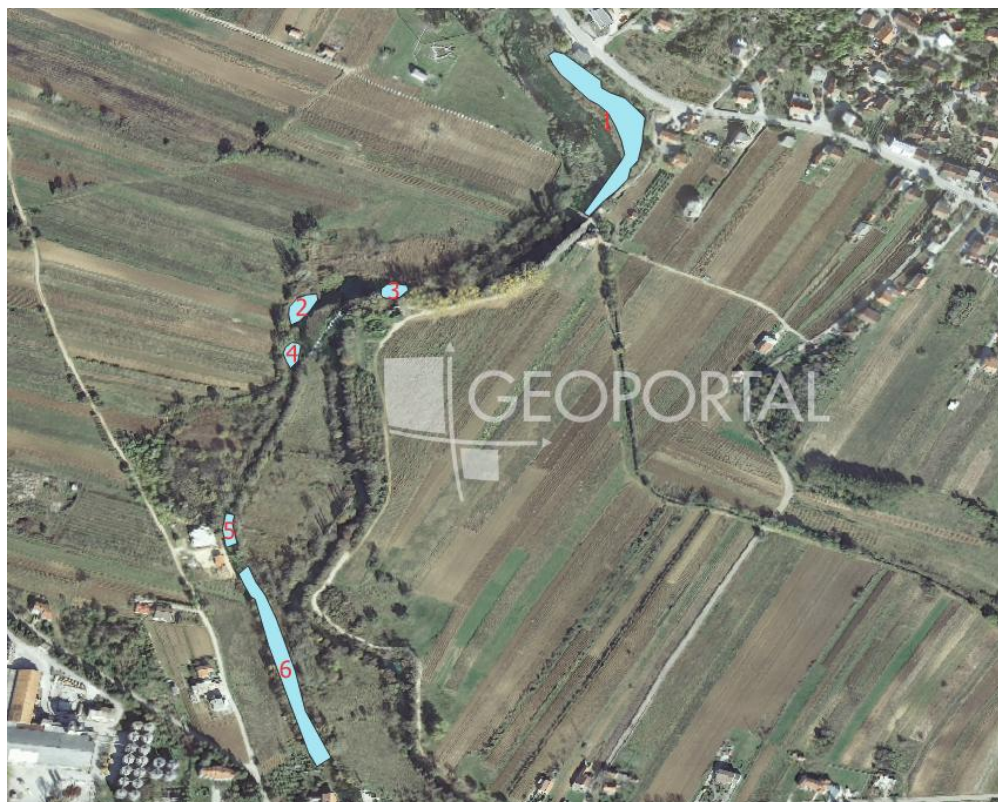
Figure 3. View of the macrophyte removal area (Public Institution More i Krš, 2025b).

During September 2025, as part of the Improve River LIFE project, macrophytes and silt were removed in a pilot area within the Special Ichthyological Reserve Vrljika Spring, on the sections “from Fabe to the first barrier” (parcel no. 4940, cadastral municipality Imotski-Glavina), in the channel (parcel no. 5253, cadastral municipality Proložac) leading to the mills at Perinuša, including the downstream section of the river (JU More i Krš, 2025b). The works were carried out over an area of approximately 0,8 ha (Figure 3), covering sections of the watercourse with the densest macrophyte vegetation. Special attention was given to areas above barrier 1 (Opačica) and barrier 2 (Stari vodovod), where the densest macrophyte growth was present. Since this is a protected area and part of the Ecological Network, a prior assessment of the intervention’s acceptability for the network was conducted, and permission was obtained from the Ministry of Environment and Green Transition. The removal activities were carried out during low water levels, exclusively using machine-assisted removal from the riverbank, in cooperation with Croatian Waters, and under the professional supervision of the Public Institution More i Krš. Workers did not enter the riverbed, and the machine was equipped with a perforated bucket that allowed water to return to the river during loading.

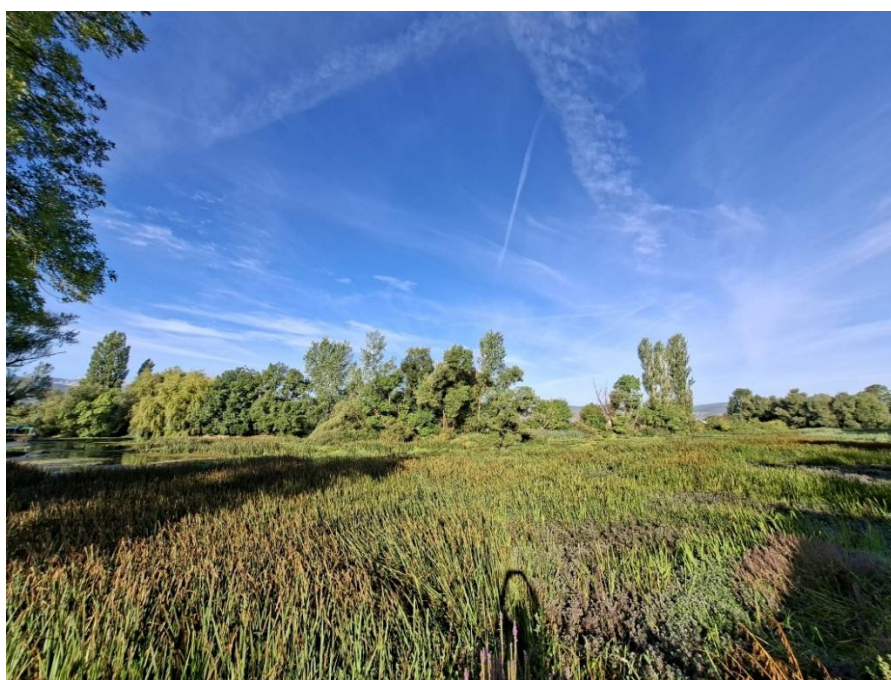
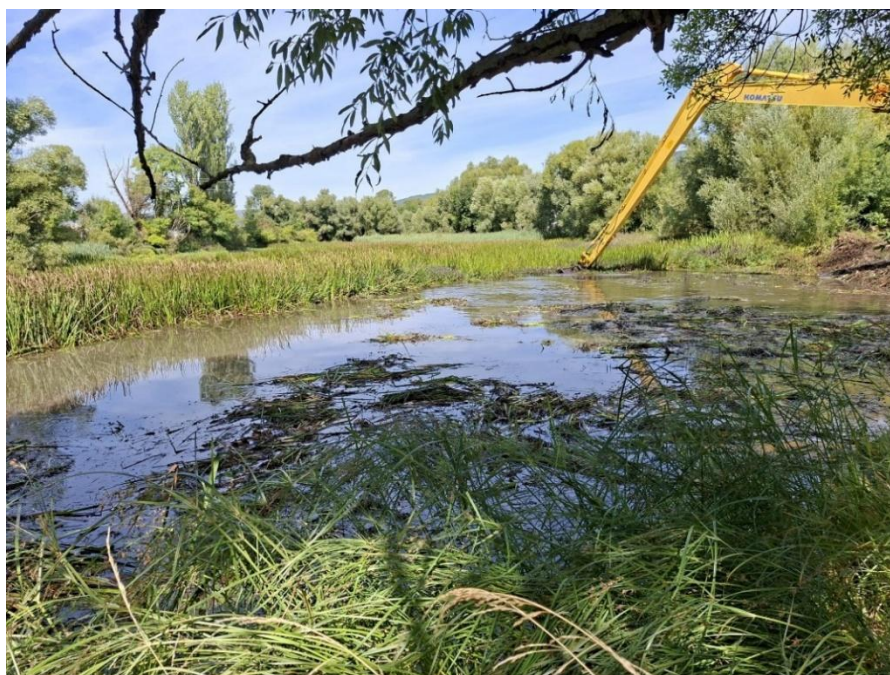
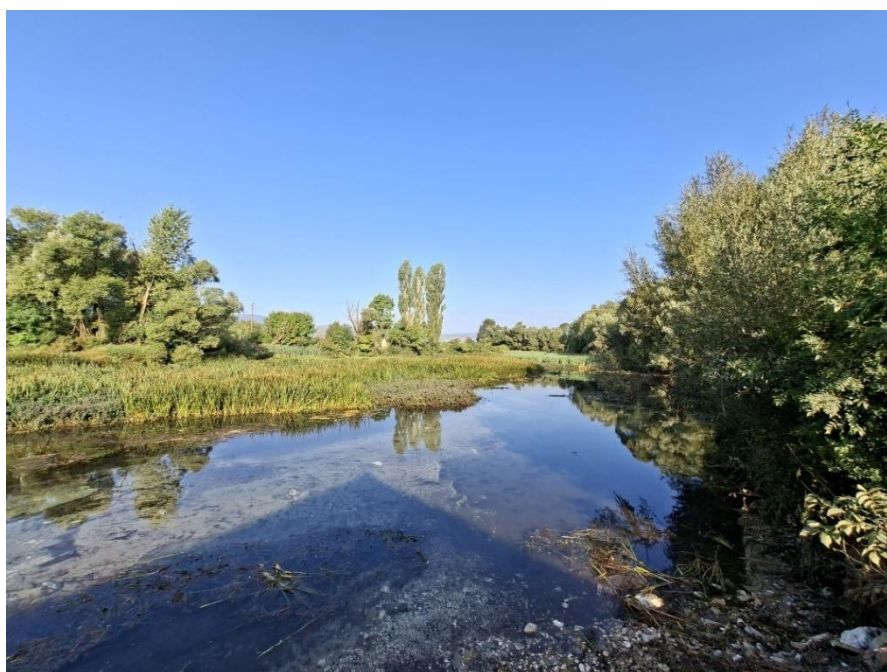
Figure 4. Situation at the site before macrophyte removal (a), during removal (b), and after macrophyte removal (c) in the Vrljika spring section, September 2025 (Public Institution More i Krš, 2025b).

On the section “from Fabe to the first barrier,” the natural riverbed of the Vrljika River, approximately 50 m wide, is present. Only vegetation accessible from the left bank was removed, while the right bank remained untouched. To preserve riparian vegetation, access to the riverbed was limited, and cleaning was carried out only in areas accessible to machinery and workers, along approximately 150 m upstream of Opačica (1) (Figures 4 and 5).

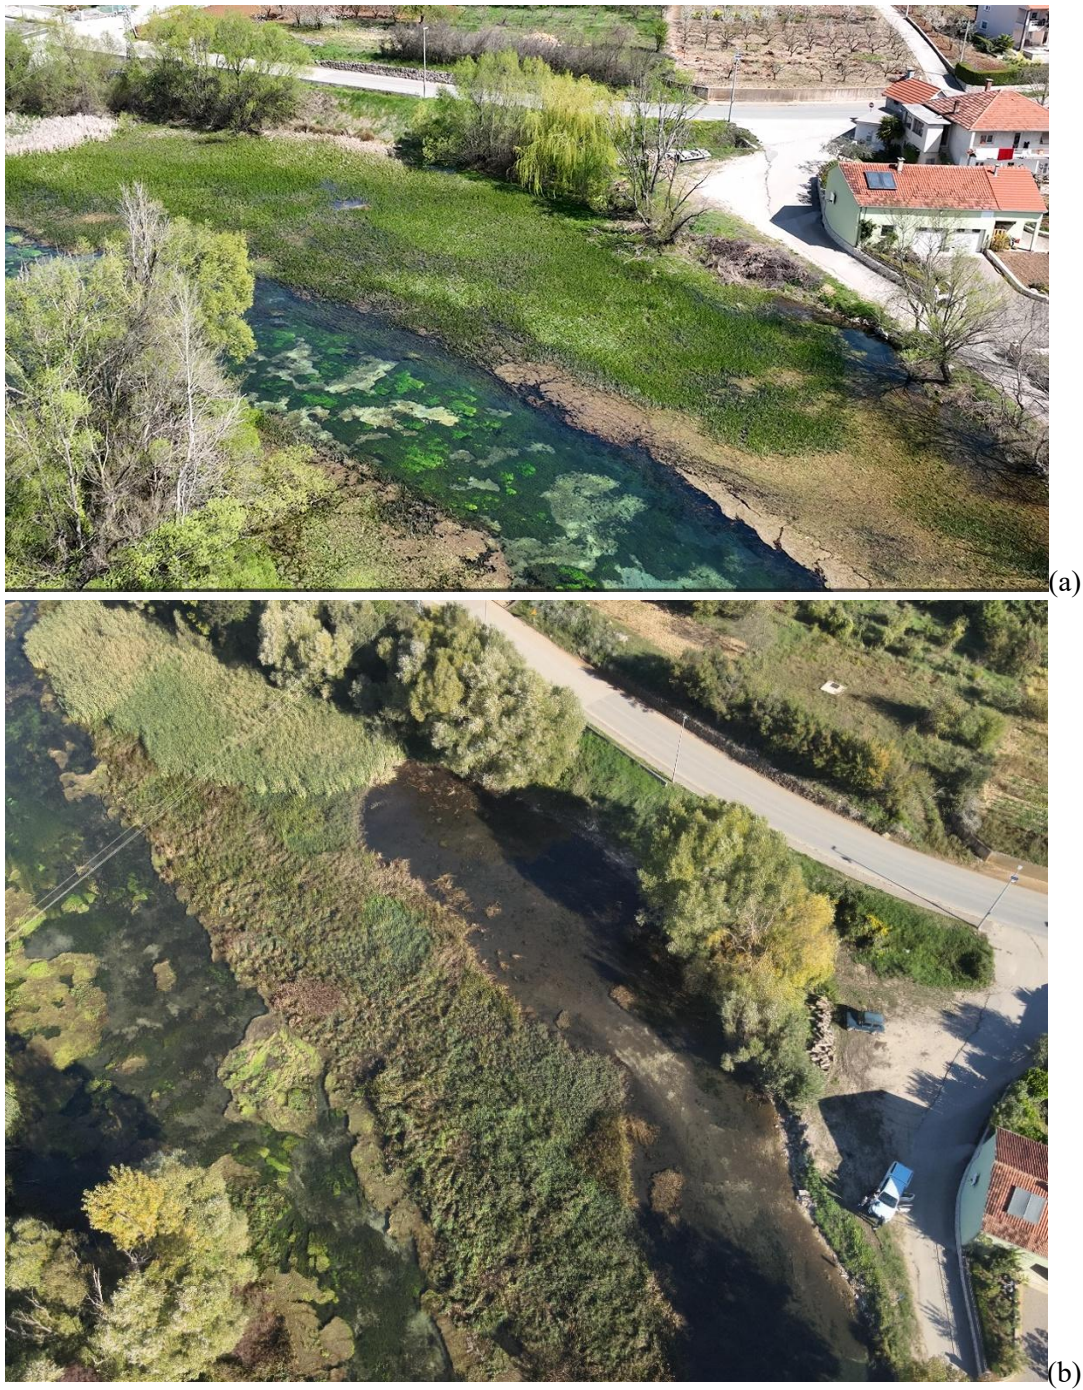
Figure 5. Comparison of drone images of the Opačica barrier in March 2023 (a) and after macrophyte removal in September 2025 (b) (Public Institution More i Krš, 2025b).

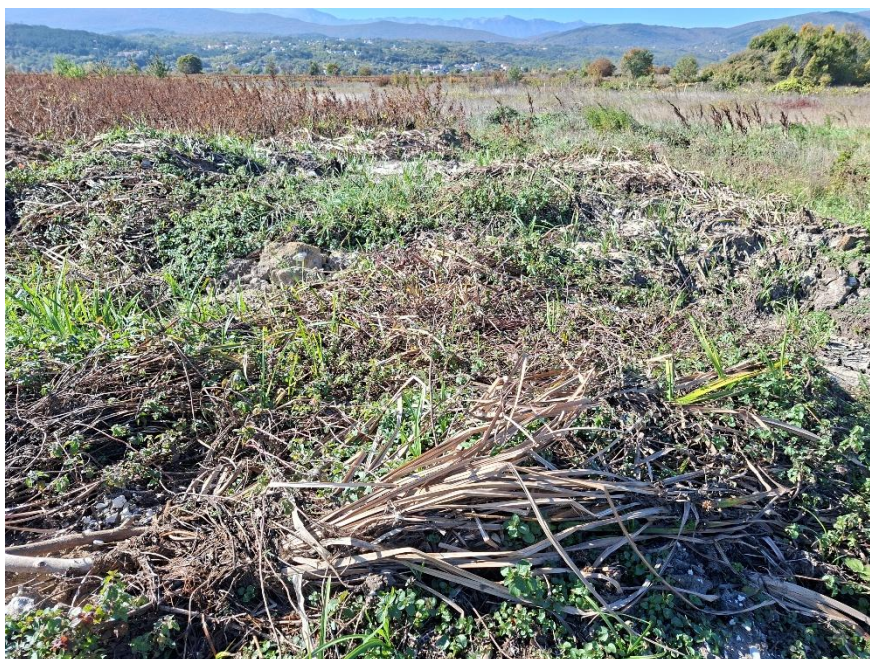
Figure 6. Removed macrophyte vegetation after loss of water content, 7 October 2025 (Public Institution More i krš, 2025b).

All removed wet biomass was temporarily stored outside the flood-prone area for drainage and drying by an authorised contractor (Figure 6). The material consisted exclusively of several macrophyte species (*Typha* spp., *Mentha aquatica*) and silt. After drainage, it was agreed that the removed biomass would be transported to the Metković Composting Facility.
