Chemical Accident Prevention & Preparedness

Learning from incidents involving liquefied petroleum gas (LPG)

This 14th issue of the Lessons Learned Bulletin (LLB) accompanies the publication of the JRC's Good Practice Report on Risk Management and Enforcement on Liquefied Petroleum Gas (LPG) and Liquefied Natural Gas (LNG) Sites. The Good Practice Report provides an extensive description of the properties of LPG and typical risks associated with LPG production, storage and handling. This issue of LLB focuses on incidents involving LPG mostly on fixed sites however many incidents with LPG on transport have been considered as well. In total 88 incidents have been studied for the purpose of this LLB.

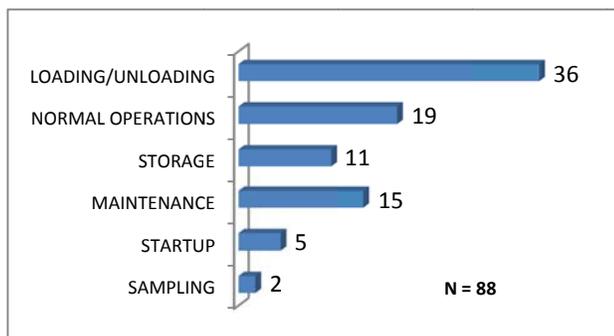
Figure 1 Type of activity underway when the incident occurred

The reports give evidence that releases occur more often during activities that involve opening or handling the LPG containment as opposed to when a tank or cylinder is operating in steady state, e.g., fueling a system or when no intervention takes place in storage. A release event occurred during a loading/unloading in 41%, or 36, of the 88 events studied (see Figure 1). There was also a notable number of events (29% or 26) associated with other types of interventions requiring opening the container, or refilling or unloading, including maintenance and startup operations, sampling and interventions such as draining, during storage. Although 11 events (13%) occurred in storage, four of these events were during some type of intervention on the tank during storage. A little over 22% of events (19) occurred during normal operations, meaning that the report did not implicate any direct activity on the LPG tank as a trigger for the sequence of events.

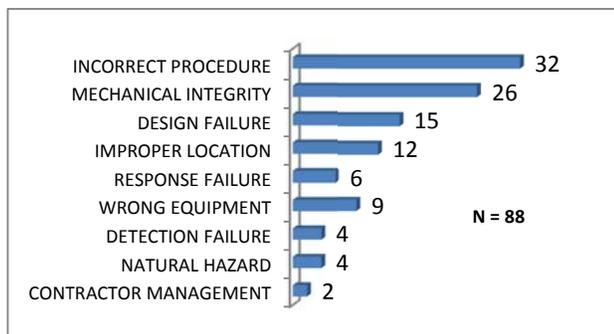
Figure 2 Underlying causes associated with the LPG release events analysed. An event can be associated with more than one failure.

As shown in Figure 2, the triggering event for several incidents was linked most commonly to an equipment failure, but sometimes also to human action (incorrect procedure, illegal action). The most common type of failure involved a valve operation, a situation that occurred in a little over a third of the incidents (32). An additional 34% of the events (30) could be attributed to either a pipe or hose failure, usually due to a mechanical integrity failure or a failure at the joint.
